Manhole Inspection Summary

Manhole # S09GG2002MH

Insp Date: **10/30/06 2:01 PM**

Location Address: **6015 PIMILICO RD**

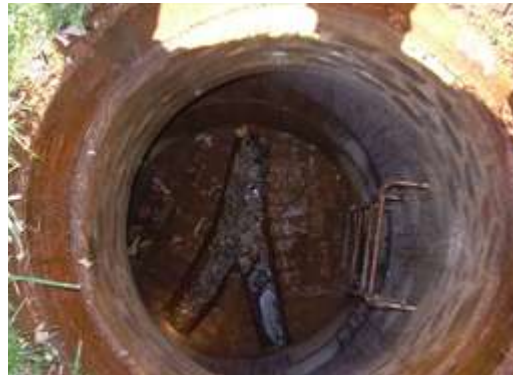
Top View

Bench and Channel debris.

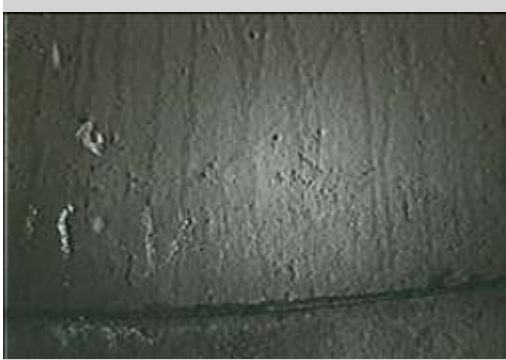
Defect

Corbel and Barrel infiltration.

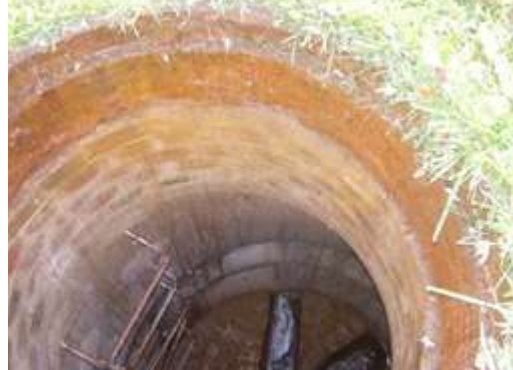
Defect

Frame leaks. Adjustment deterioration and infiltration. Corbel and Barrel infiltration.

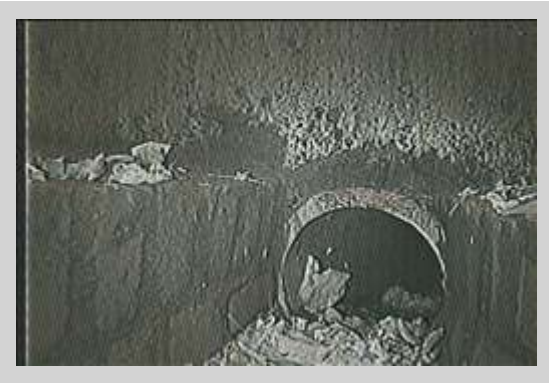
8 in. Circular Gravity Sewer Pipe Out @ 12 O'Clock

Deposits: ☐ None ☒ **Mud** ☐ Sludge ☒ **Debris** ☐ Grease

Silt Depth: **0.5** (in.) Deposits Extent: **Light**

Infiltration: **Evidence** Pipe Seal Cond: **Unknown**

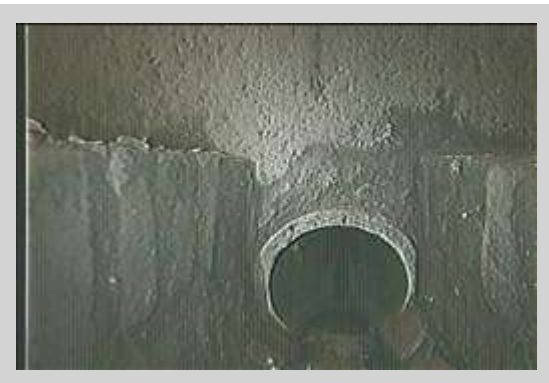
6 in. Circular Gravity Sewer Pipe In @ 5 O'Clock

Infiltration: **Evidence** Pipe Seal Cond: **Unknown**

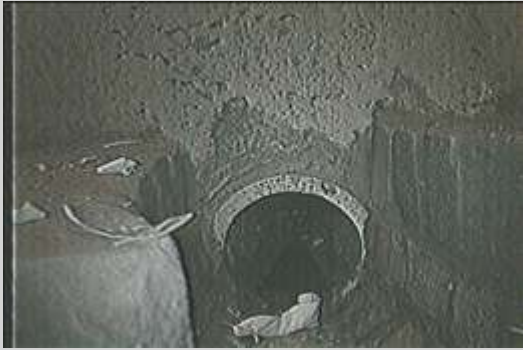
Pipe In @ 7 O'Clock

Deposits: ☐ None ☒ **Mud** ☐ Sludge ☒ **Debris** ☐ Grease

Silt Depth: **0.5** (in.)

Infiltration: **Evidence**
